Inspection Report

WISER PROPERTY INSPECTIONS

PROPERTY INSPECTION REPORT

Inspected address

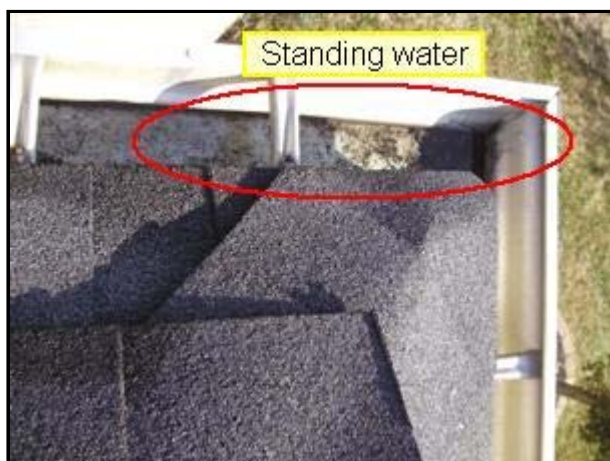
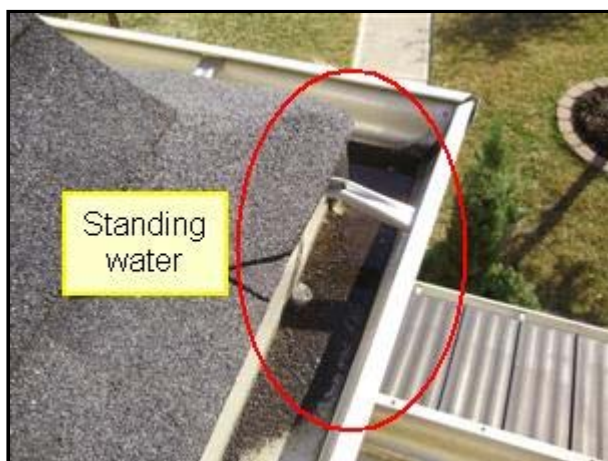
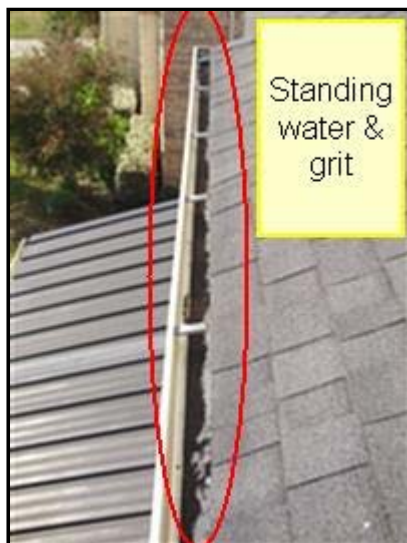
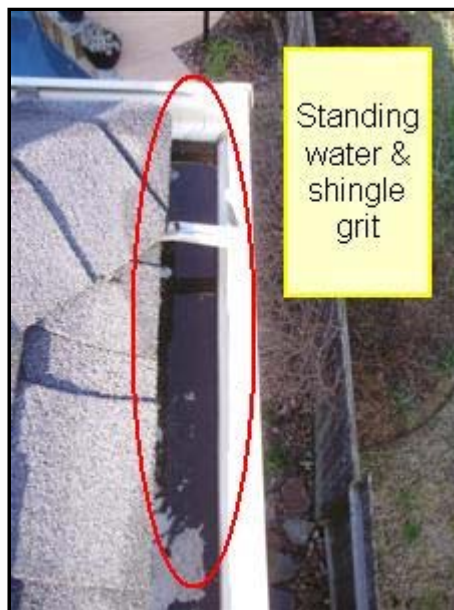
(1) The gutter is holding water due to incorrect slope towards downspout at several locations of the home. Gutters that drain poorly can lead to costly problems such as deterioration of fascia, soffit or roof edge. It can also cause gutters to pull loose and lead to possible water intrusion. A qualified contractor should inspect and repair as needed.

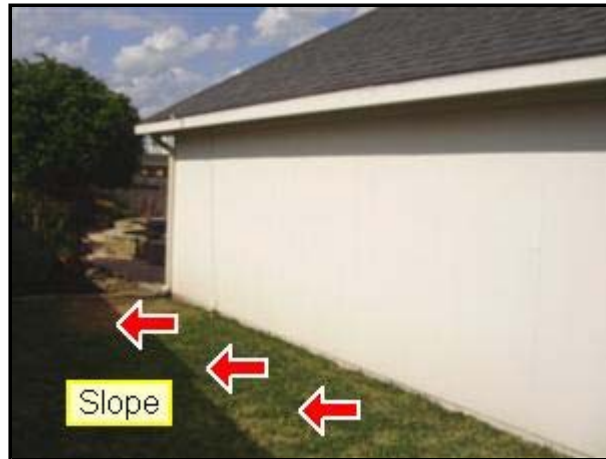
B. Picture 5

(2) There is very little ground slope away from the back of the garage. Recommendations call for a minimum of 6" drop in the first 10' in order to control the detrimental effects of water. One solution might be to install an area

drain or French drain and connect it into the patio drain system.

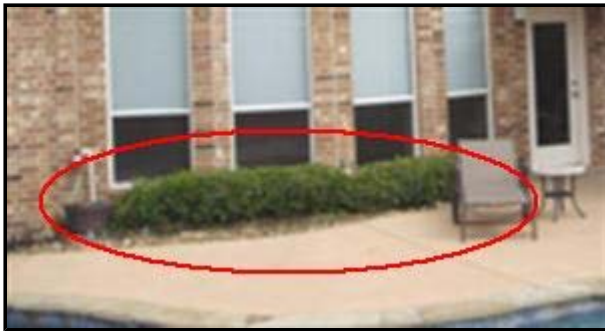
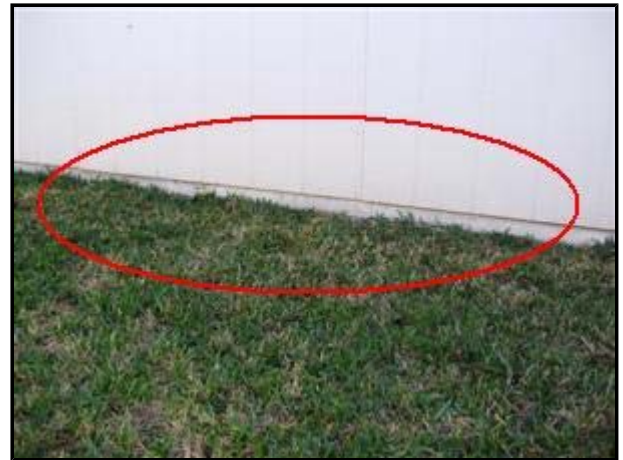
(3) Ground clearance at the back of the home and back of the garage is much less than the recommended 4" for brick facades & 6" for siding. This should be corrected as soon as possible.

Until repairs are undertaken, be aware of the possibility of vegetation growing into the weep holes or between siding and slab.

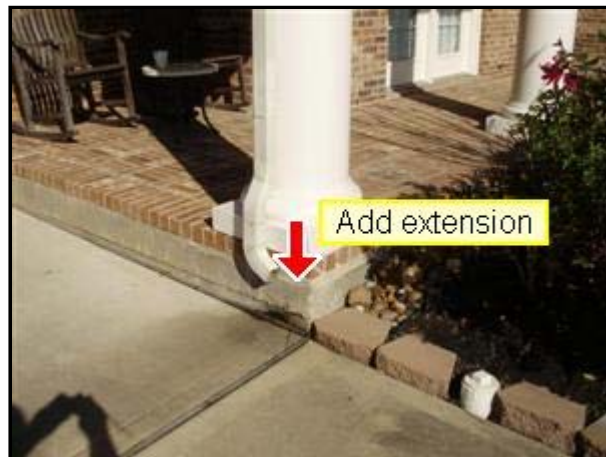
B. Picture 8

(4) A short extension could be added to the downspout at the left corner of the home which would reduce the amount of water that is seeping between the driveway and slab at the expansion joint.

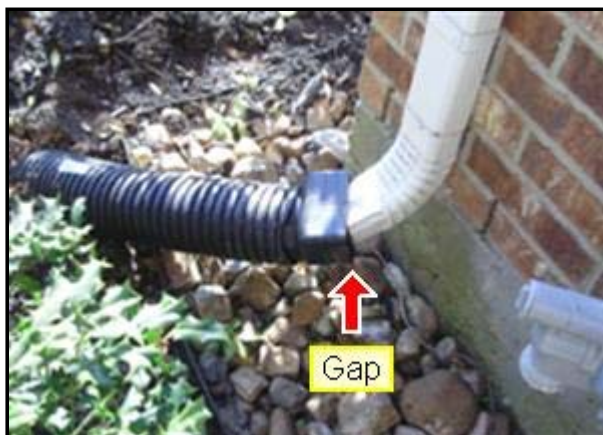
B. Picture 9

(5) The flexible extension added to the downspout at the right front corner of the home needs to be adjusted so

that water doesn't escape at the corner of the home.

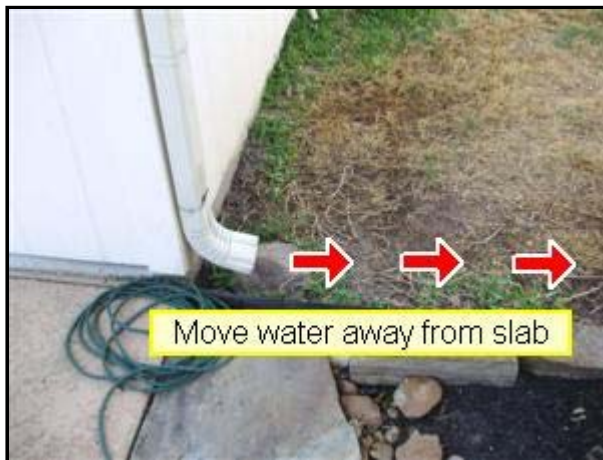
B. Picture 10

(6) The downspout is missing an extension at the rear of the garage. Downspout extensions are needed or erosion or water intrusion can occur.

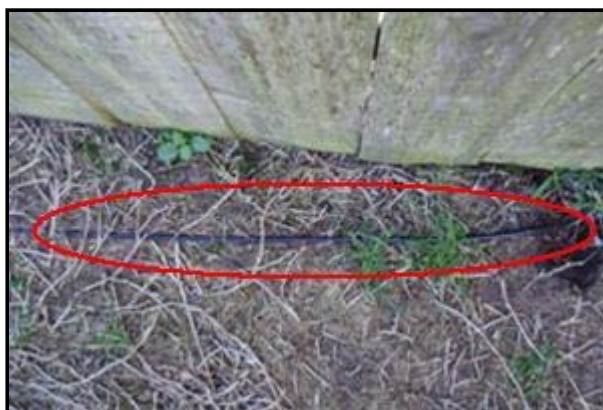
B. Picture 11

(7) A wire assumed to be coax (cable) was noted above ground behind the garage. This is for your information.

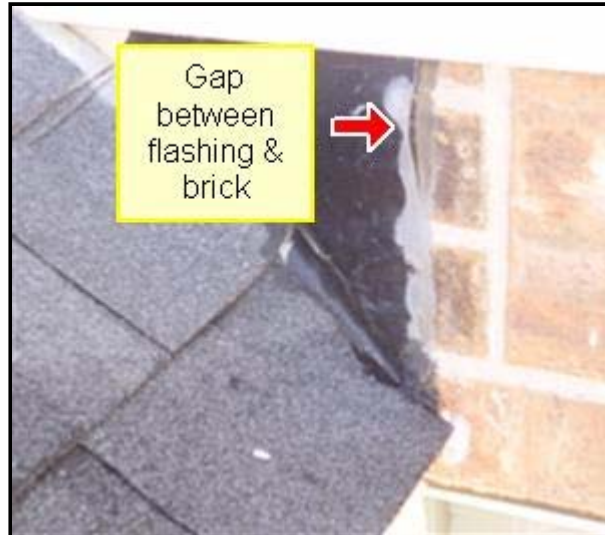
C. Picture 1

(3) The flashing is caulked along the top edge instead of being inserted into the mortar between the bricks. This is a common but non-standard practice. Monitoring is recommended. Repair with roofing caulk.

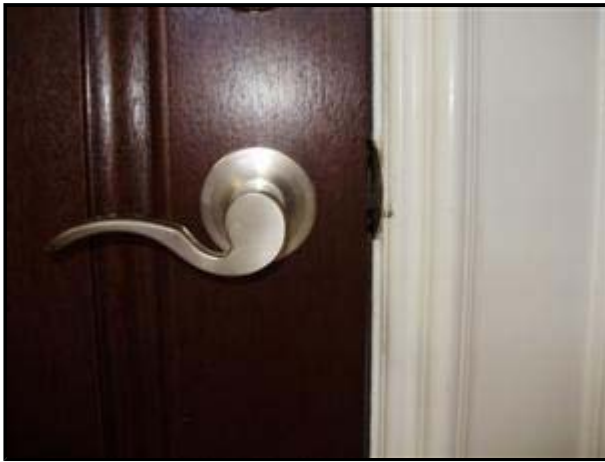
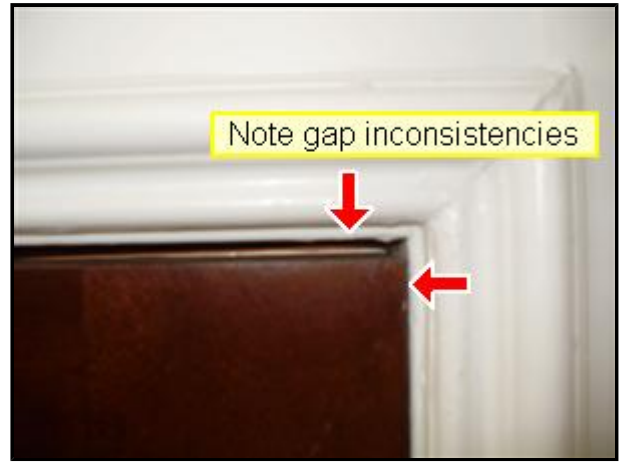
(1) The main entry door needs strike and latch adjustment to shut tight. This is a maintenance issue and is for your information. A qualified contractor should inspect and repair as needed.

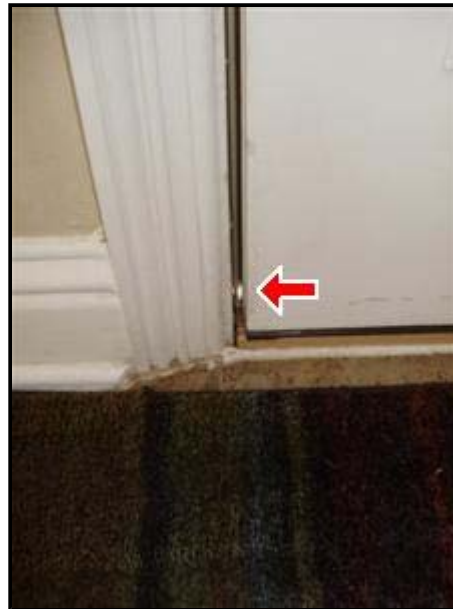
G. Picture 3

(2) The entry door at rear of home reveals daylight at threshold when latched. This can cause some heat loss in winter and loss of cool air in summer if not corrected. A qualified contractor should inspect and repair as needed.

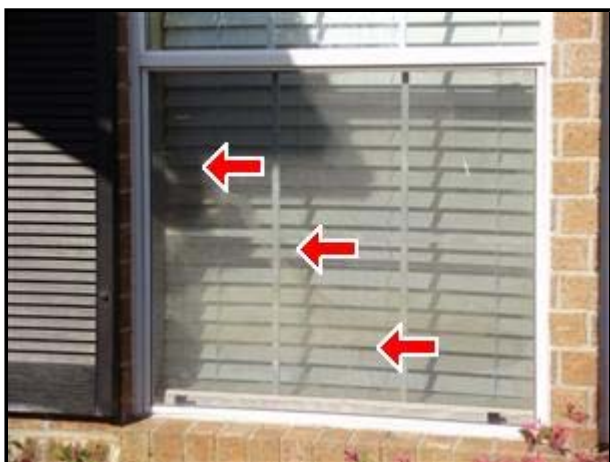
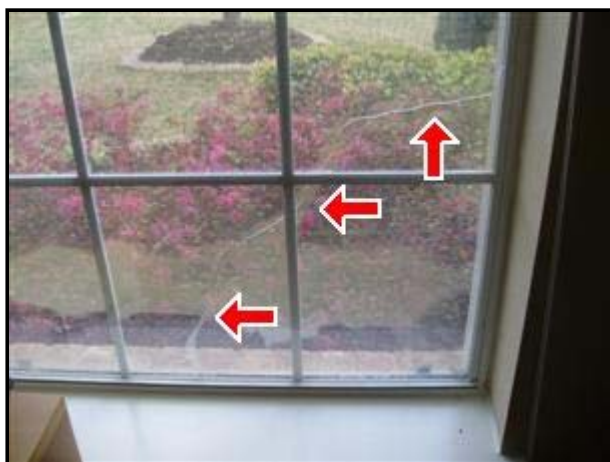
(1) One window in the study (right of main entry) has a broken pane. Since it is a double-pane style, removal is necessary to properly complete the repairs. A qualified contractor should be engaged to perform this task.

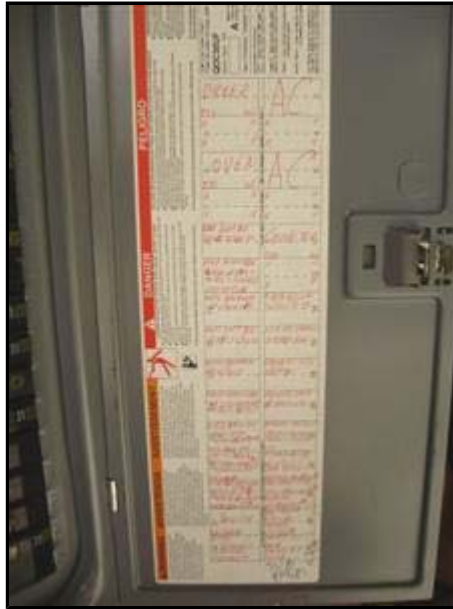
A. Picture 1

(1) The main panel box is located at the garage. The branch circuits are clearly labeled but accuracy should be verified.

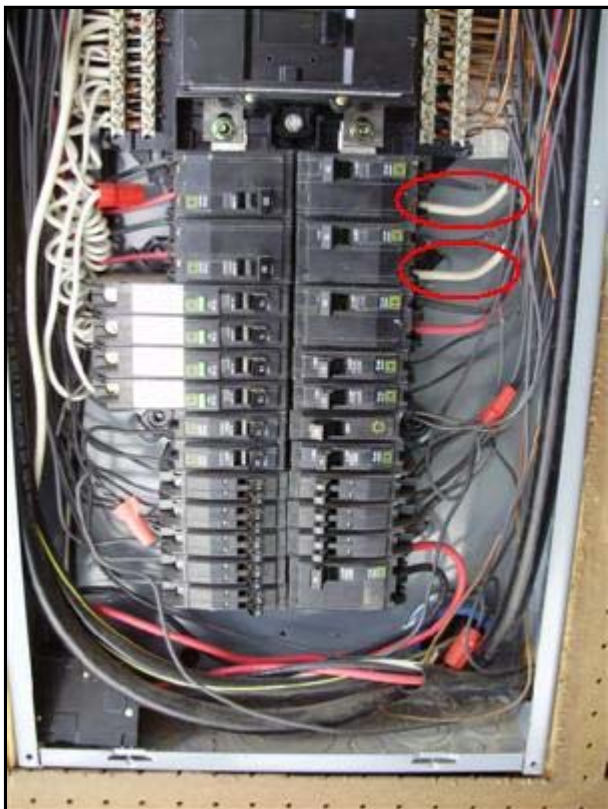
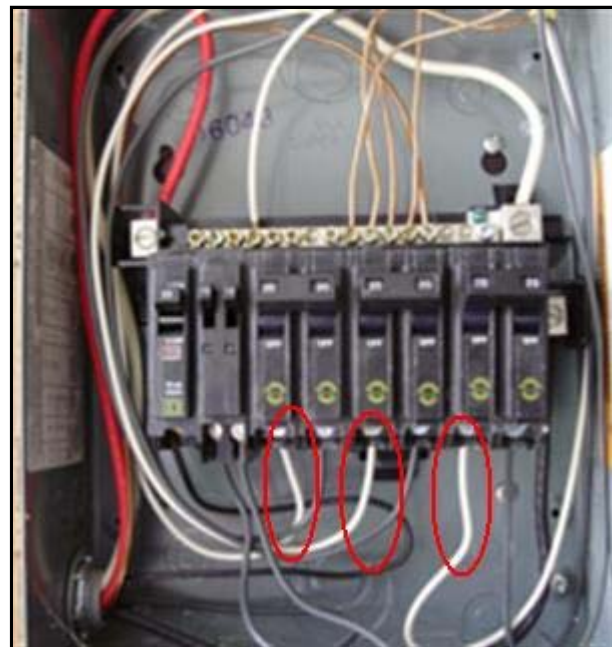
(2) The main panel and smaller sub-panel to the right have several "White" insulated branch wires which originate at a circuit breaker and supply voltage to locations throughout the property. Only "Red" and "Black" insulation is allowed for this purpose. Correction can be initiated by installing (colored electrical) phase tape at each end of the wire.

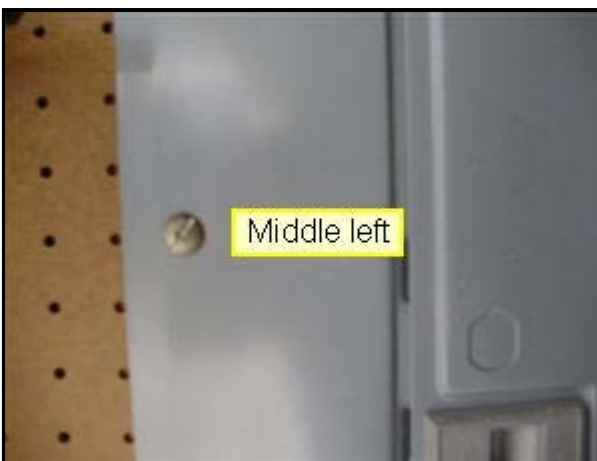
A. Picture 4

(3) One of the screws holding the cover on the main service panel has a stripped hole. This is for your information.

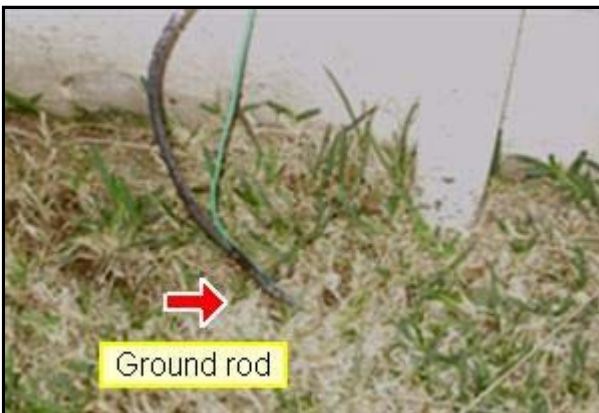
A. Picture 5

(4) A ground wire to ground rod is present below the meter but appears to have been hit by a weed trimmer or lawn mower. If the ground connection is loosened or wire damaged, a safety hazard would exist. It's recommended you periodically monitor this item and tighten or repair as necessary.

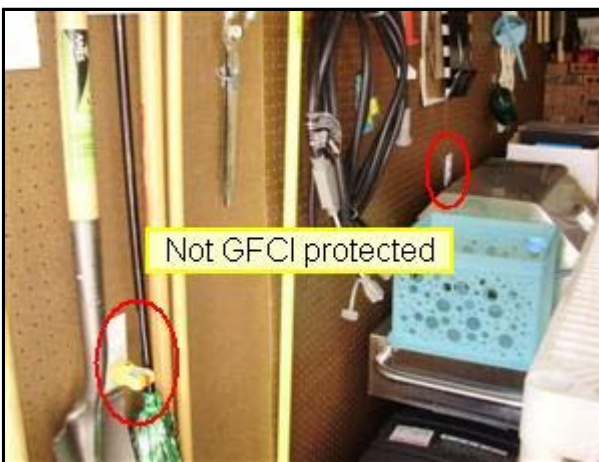
B. Picture 1

(1) All garage receptacles which are readily accessible and not dedicated for freezer, washing machine etc are required to be GFCI protected [per NEC 210.8A2,5]. Most receptacles in the garage are not properly protected. Correction by a licensed electrical contractor is recommended.

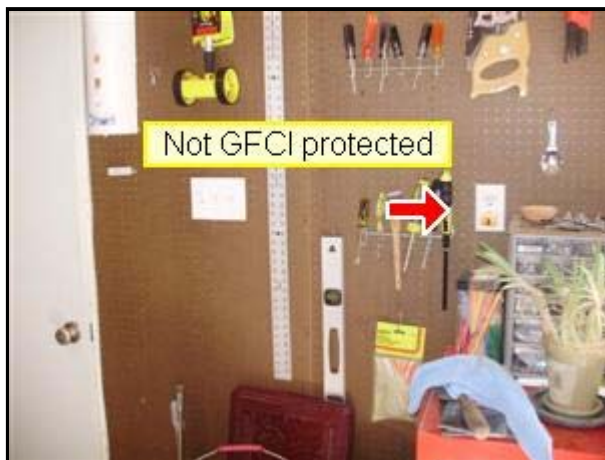
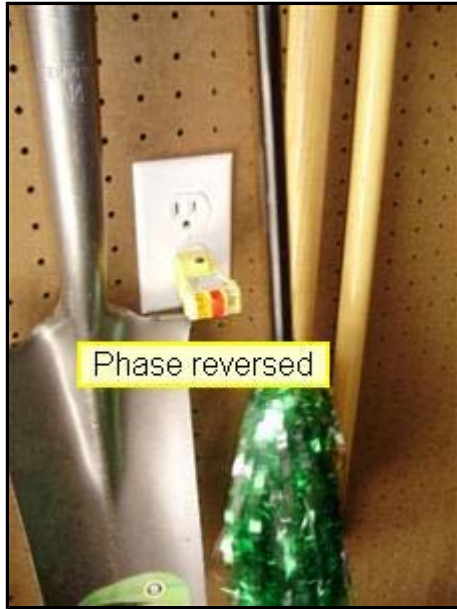
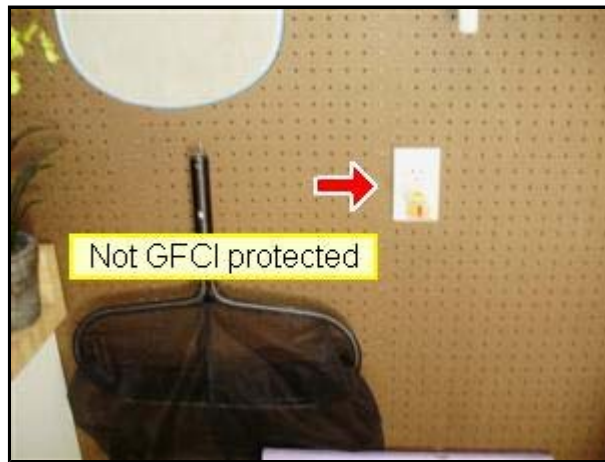
(2) One garage receptacle on the south wall was identified as being out of phase (hot & neutral wires are reversed). Correction by a licensed electrical contractor is recommended.

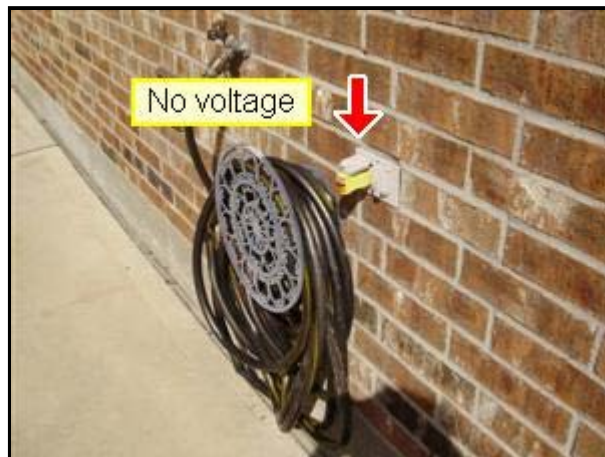
B. Picture 5

(3) No power (voltage) was identified at the external duplex outlet beside the hose bib adjacent to the driveway. This outside location requires GFCI protection and during the process of testing the other outside receptacles it was determined that the reset is located in the garage. Resetting did not restore power to this receptacle. It's possible this is a switched outlet and if true, I was unable to locate the switch which controls it. Further investigation and discussion with the present homeowners is suggested.

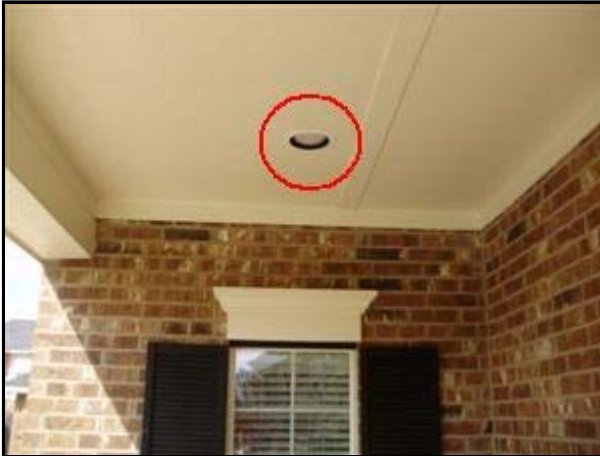
B. Picture 6

(4) One light on the far left side of the front porch did not light. This is for your information and it's presumed that the bulb is either loose in the socket or need replacing.

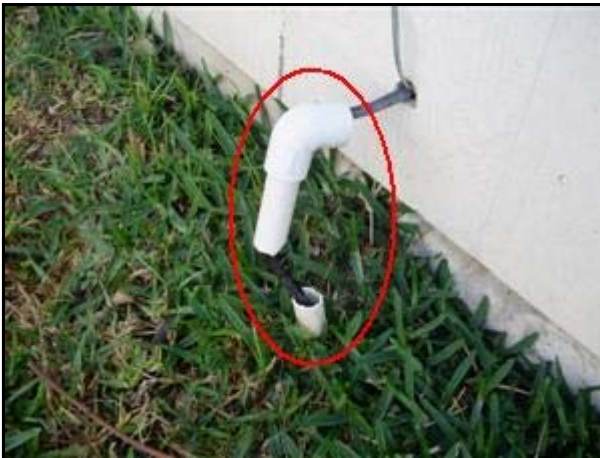
B. Picture 7

(5) The pipe & elbow covering the cable which enters the back wall of the garage from ground level is broken. The only purpose for this covering is to protect the cable from physical damage. The utilized CI-200 pipe with a very thin wall could be replaced with the same materials but a better solution would be to install plastic gray electrical conduit or Sch-40 pipe. Both recommendations have significantly thicker walls which would be less apt to break if bumped with a weed trimmer or lawn mower.

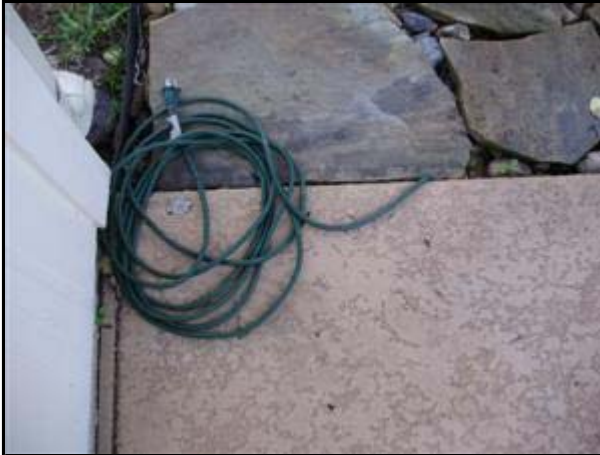
B. Picture 8

(6) Extension cords are not to be used as permanent wiring. This cord was not plugged in and the circuit controlled by it was not tested. If required for lighting or other permanent service, it needs to be properly wired.

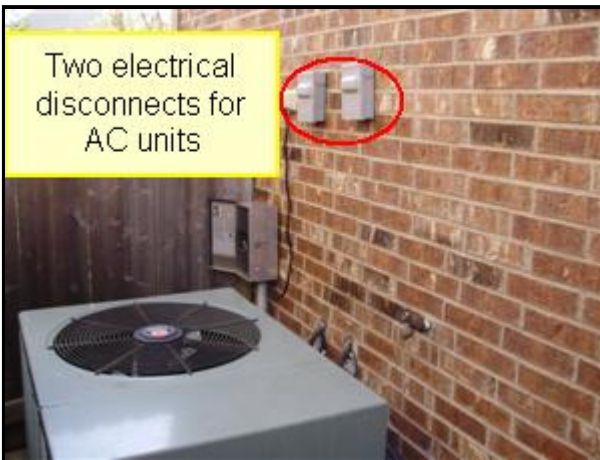
B. Picture 9

(7) Electrical disconnect switches should not be installed directly behind air conditioner condensers [2005 NEC 110.26] . This is an often compromised regulation and is provide for you information.

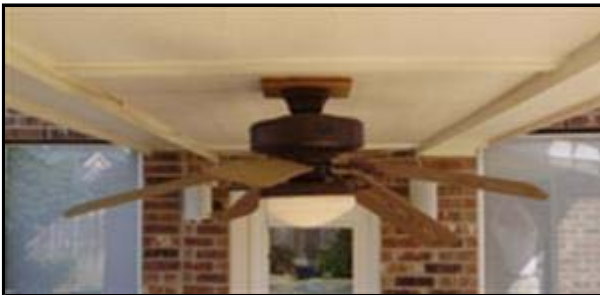
B. Picture 10

(8) Due to the overall appearance & condition of the blades, the ceiling fan was not tested for rotation. Light does operate properly.

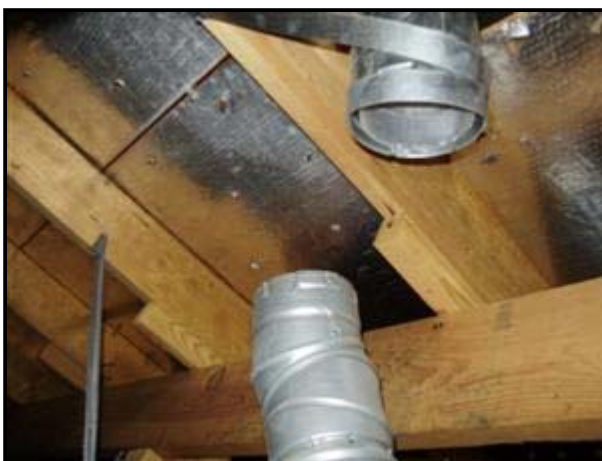
A. Picture 1

(1) The upstairs gas furnace flue vent is separated. This is a safety issue and should be repaired by a licensed HVAC contractor.

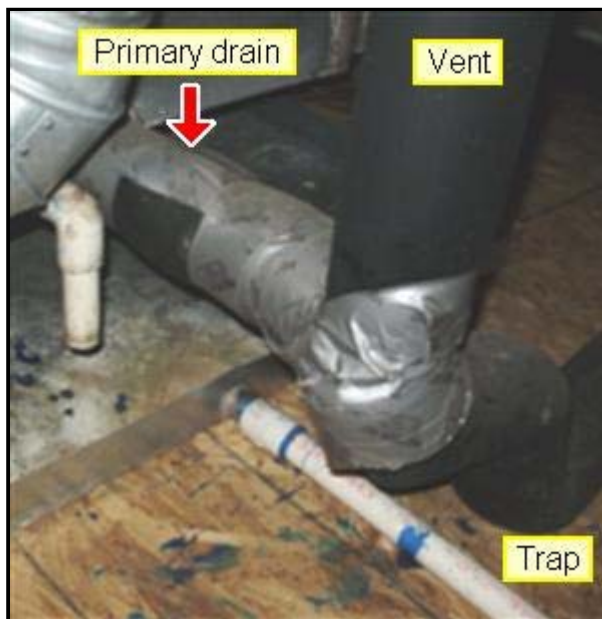
B. Picture 1

(2) Both primary drains do not have a water trap before the siphon break which results in conditioned air being discharged in the attic. To correct this situation, it's recommended that the existing vent be capped but left unglued and a new vent be added downstream of the trap. The unglued cap could then be removed when the line needs bleach added for cleaning.

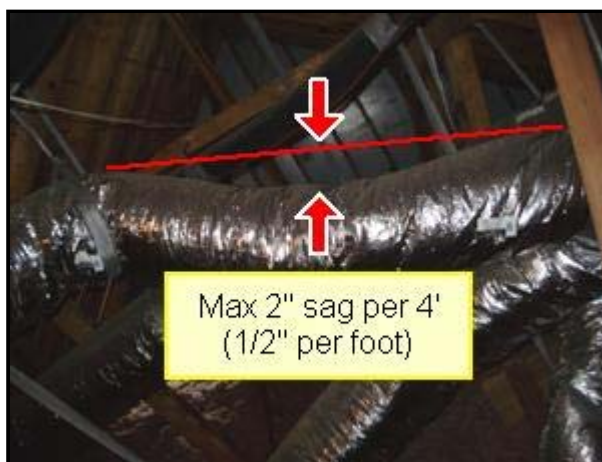
C. Picture 1

(2) Numerous portions of flex duct are sagging greater than the allowable 1/2" per foot (max 2" sag between 48" straps). Correction is recommended by a licensed HVAC contractor.

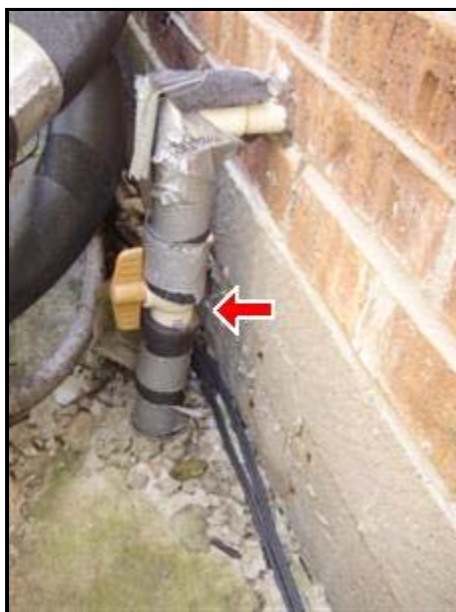
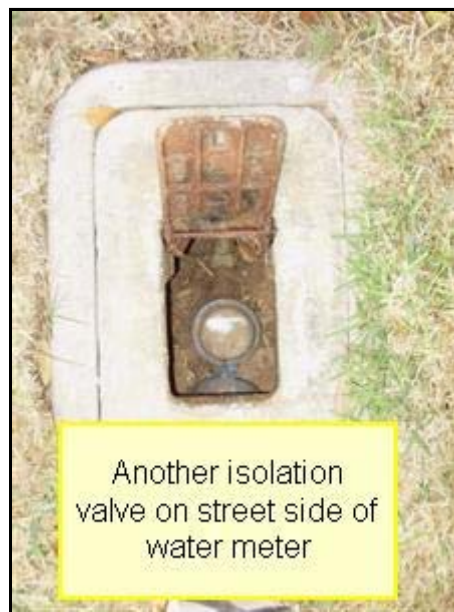
(1) The water shutoff is assumed to be the ball valve located behind the AC condensers (please ask the current owners to confirm). While ball valves are acceptable for this function, sunlight does degrade plastics and it's possible the handle could break if/when the valve needs to be closed. Because of their much slower closing rate, gate, globe and diaphragm valves don't put as much stress on the handle therefore are better served for this application. If a plumber is solicited for another task, you might consider upgrading this valve to one of the 3 mentioned. In the event the valve isn't upgraded and it breaks, another valve is located on line feeding the water meter.

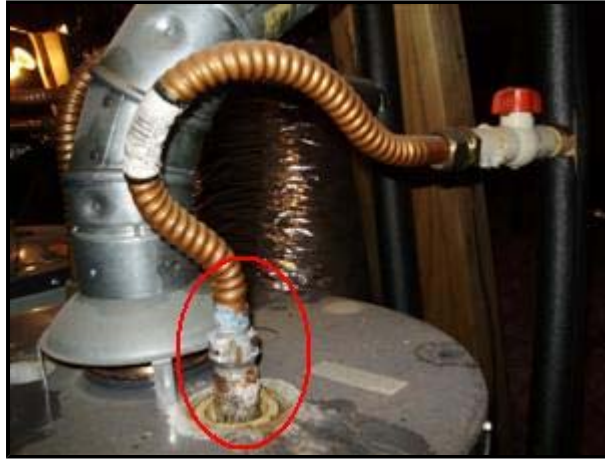
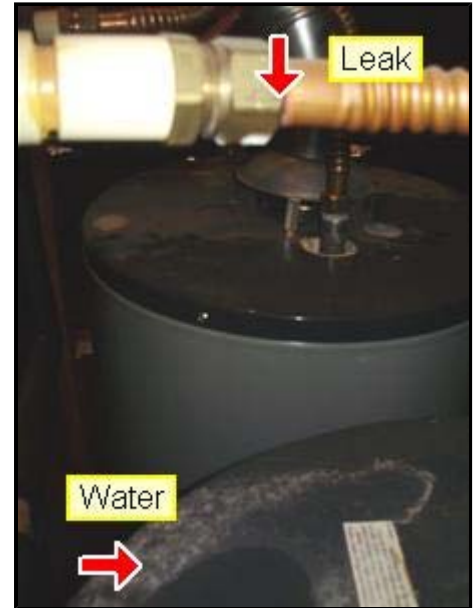
(1) Both water heaters have leaks at the plumbing connections. Leaks can cause damage to unit or home. If galvanized pipe and copper flex line is joined, a dielectric union should be used. A qualified licensed plumber should repair this deficiency.

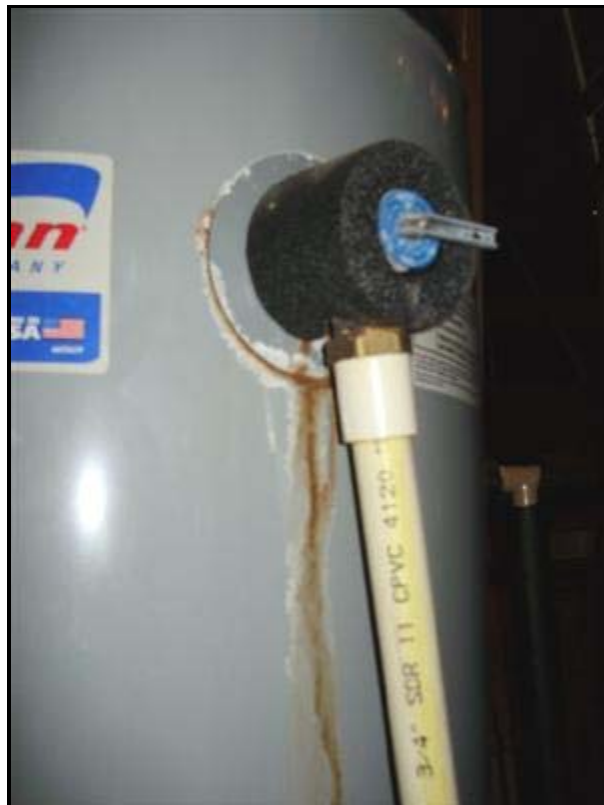
C. Picture 3

(2) Evidence of a past leak was seen at the TPRV (temp & press relief valve). This is for your information.

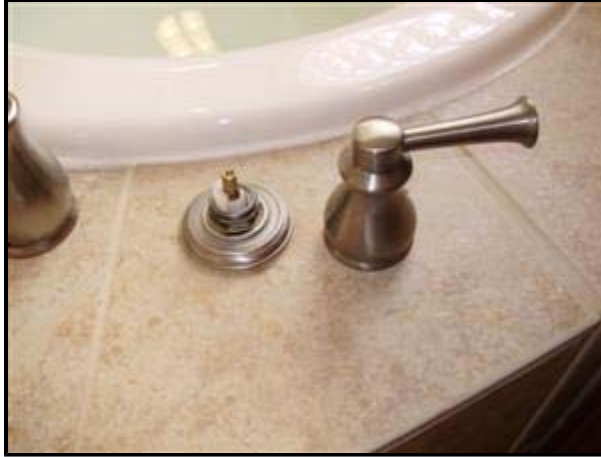
D. Picture 1

(2) One water valve handle needs the set screw tightened.

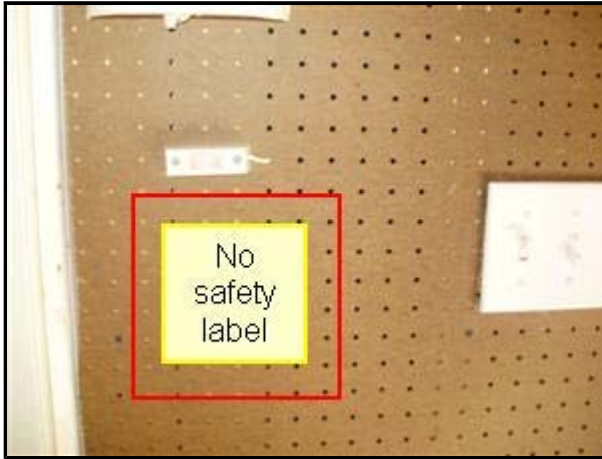
H. Picture 1

(2) Automatic garage door wall-mounted control button does not have Red, Black, Orange & White SAFETY DECAL located near the control button.
