Inspection Report

WISER PROPERTY INSPECTIONS

PROPERTY INSPECTION REPORT

Inspected address

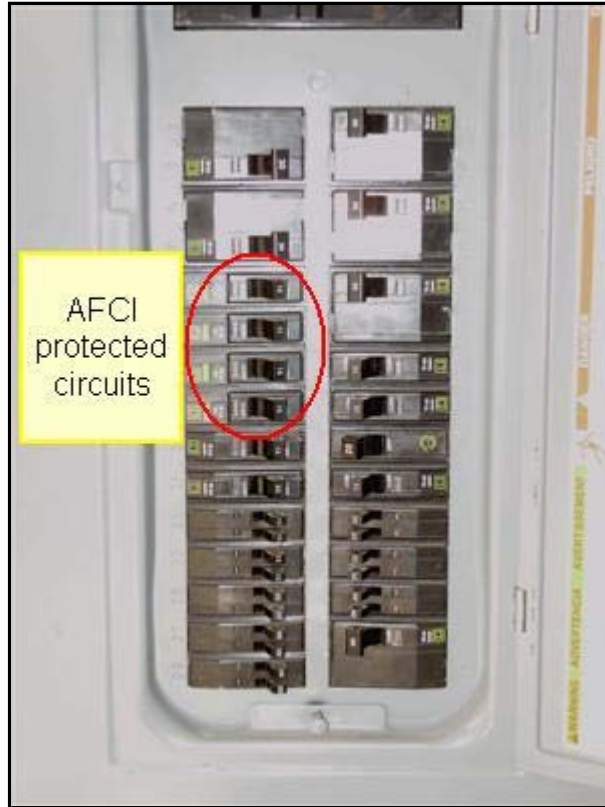
B. Picture 11

(9) There is a lack of arc-fault circuit interrupting devices (AFCI) for family rooms, living rooms, recreation rooms, closets & hallways. These devices were only required in bedrooms when the home was built but the requirement has since been upgraded to include all non-appliance 120VAC circuits. Unless a home is a recent build, it's doubtful this requirement has been met.

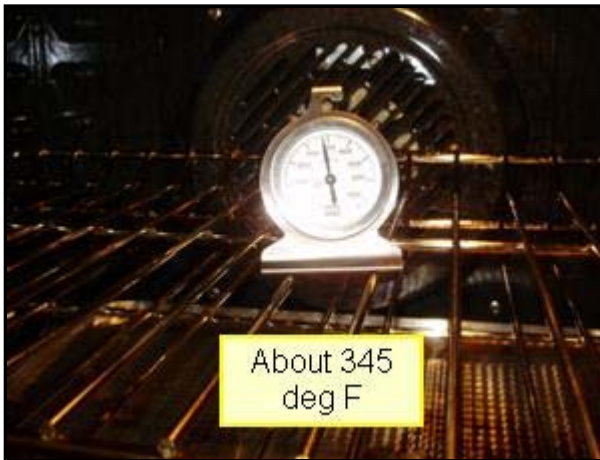
D. Picture 1

Oven tested at 350 deg F and found to be within +/- 25 deg.

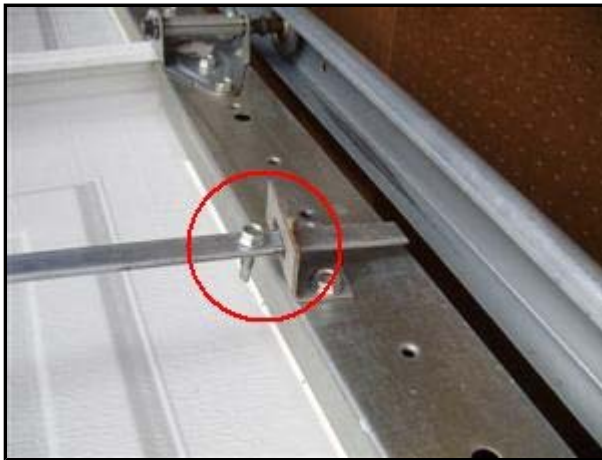
H. Picture 2

(4) Garage lock properly disabled.

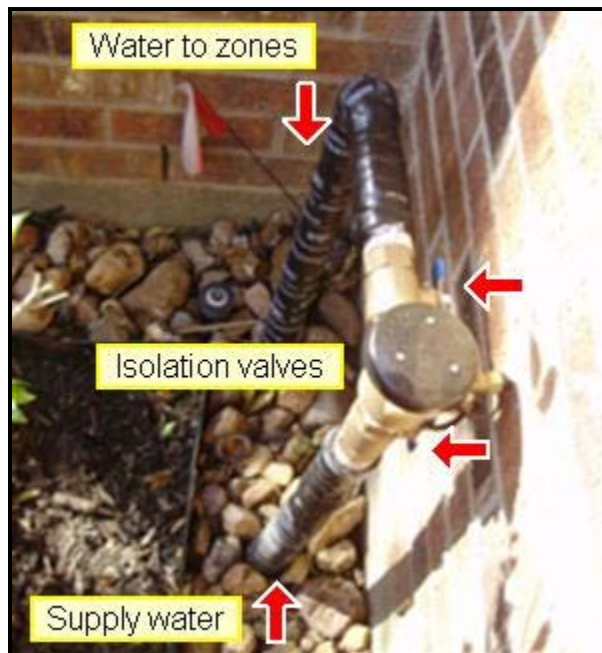
A. Picture 2

(3) Anti-siphon valve is located in the front and on the right side of the home. In freezing temperatures, a plastic component under the lid may break when the water expands and turns to ice. It is the weakest component of the valve and by failing, keeps the housing from cracking. To minimize the possibility of the plastic part failing, the water supply valve can be closed and the valve housing drained.

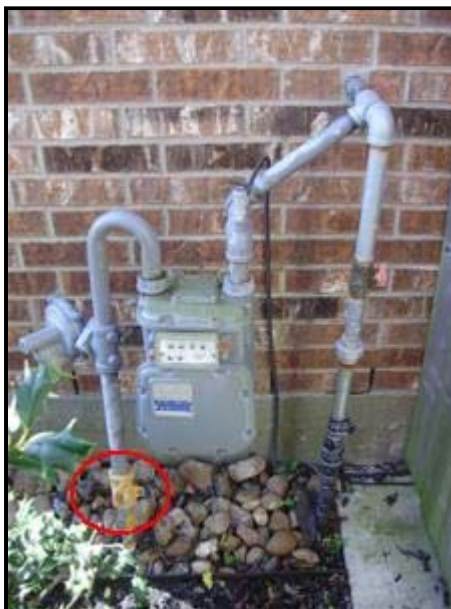
E. Picture 1

Gas meter is located on the right side of the home. Isolation valve is circled.

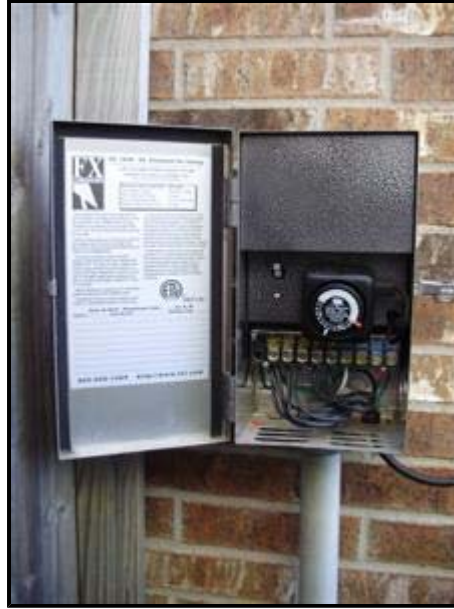
I. Picture 1

- (1) Proper operation and temperature inside wine cooler were not confirmed.
- (2) Low-voltage lighting was not tested.
